Hyundai Clutch Disc Correct Orientation

Ref: TN084

Issue date: June 2015

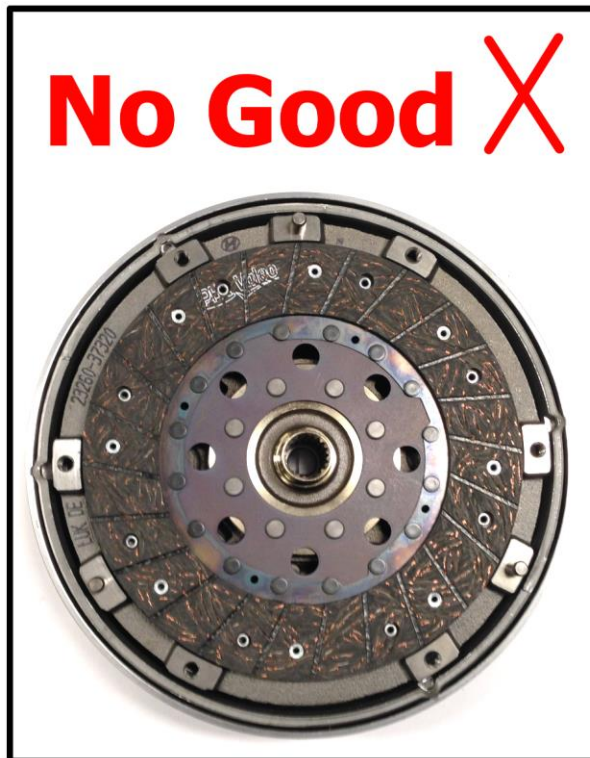
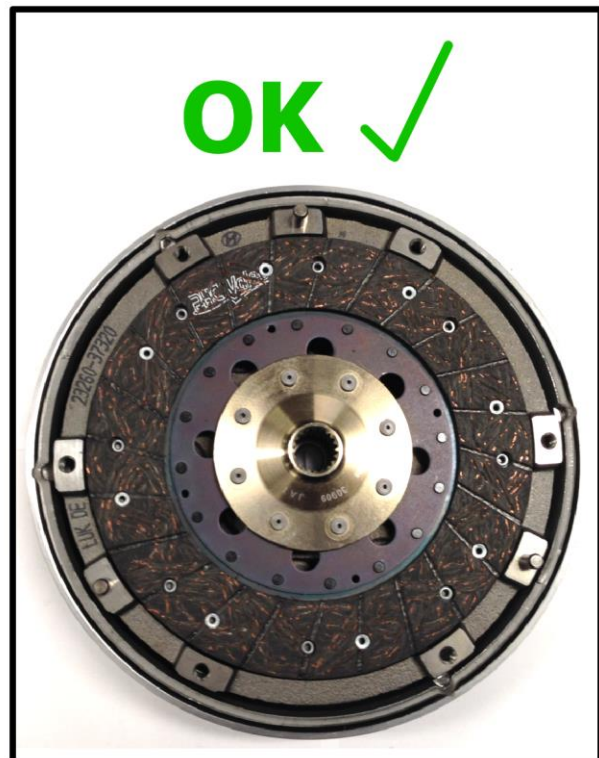
It is important to ensure that the 'raised' section of the clutch disc spline hub is facing the transmission as depicted below. Failure to orientate the disc correctly will result in a disengagement problem (unable to select gears) and/or damage to the clutch cover and flywheel.
