Ford XR8 FMK-7893SMFHD Clutch Kit Fitment

Ref: TN050

Ford XR8 FMK-7893SMFHD Clutch Kit

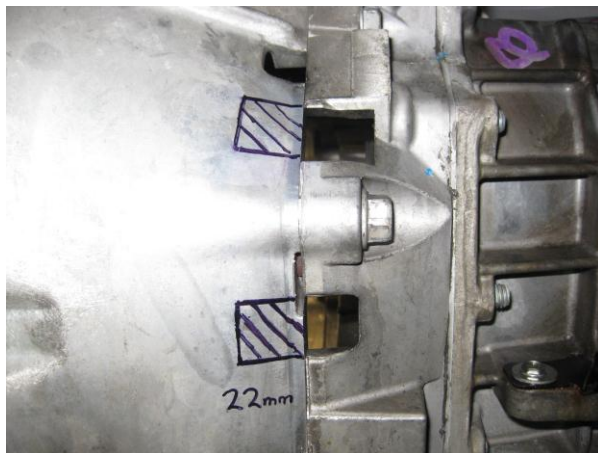
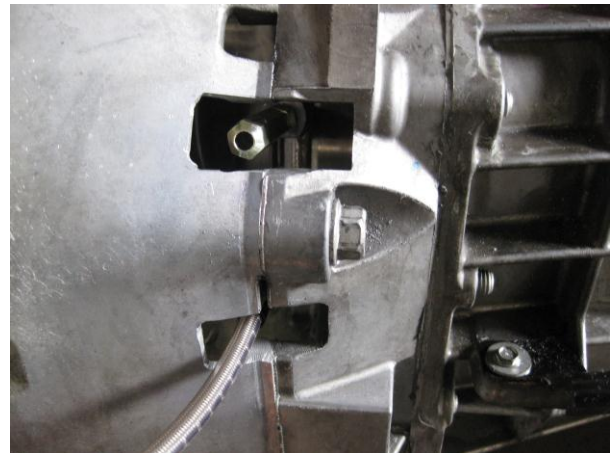
To allow access to the bleed nipple and clearance for the delivery line, the bell housing should be relieved as shown in the images below.

This is necessary as the ten (10) mm spacer between the CSC and transmission is required to re-position the CSC.
