Toyota Landcruiser Prado 3.0L 1KD-FTV engine clutch release bearing removal

Ref: TN037

Issue date: 04 Nov 2009

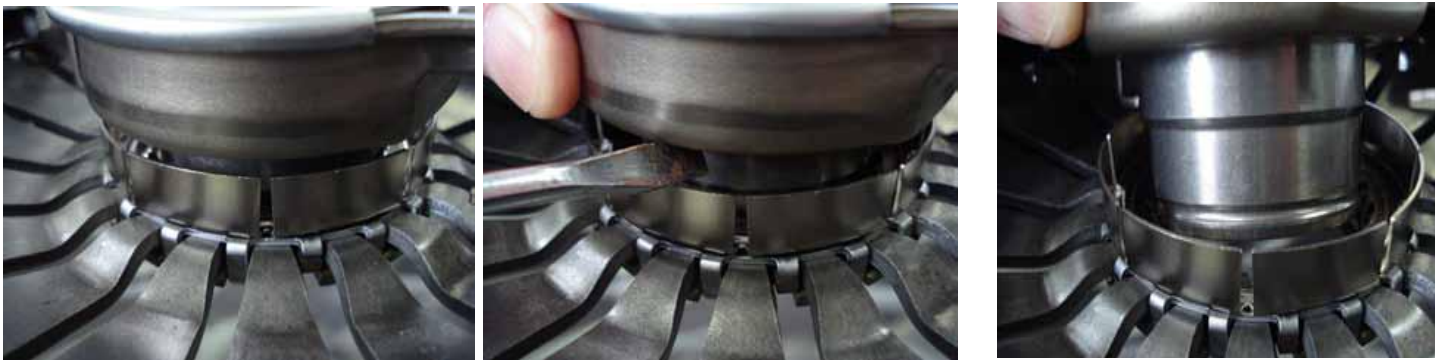
Removal technique of clutch release bearing: -

1. Withdraw the transmission approximately 30 mm.
2. Insert a flat blade screw driver between the collar and bearing.
3. Twist screw driver 90 degrees and remove the bearing.

Installation technique of clutch release bearing: -

1. Locate the clutch release bearing on the gearbox front bearing retainer (snout).
2. Locate the throw out fork on the release bearing.
3. Position transmission to the engine block.
4. Operate the fork opposite direction for clutch release.
5. This will snap the bearing into the cover assembly.
